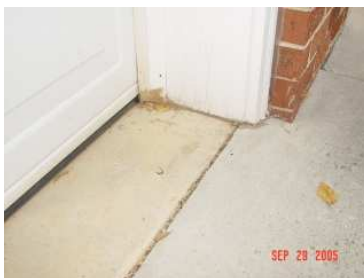
5. Summary Page Item:

Garage door trim has a few places that are starting to deteriorate. I tested the deteriorated trim with a small probe.

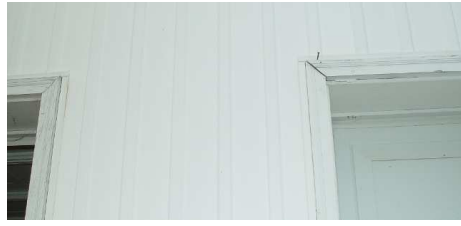
6. Paint is deteriorating and peeling above the garage door and also at the small entrance door on the south end of the home. These areas will let deterioration occur if not corrected. These areas need to be repaired by licensed general contractor or professional painter. 3 photos below

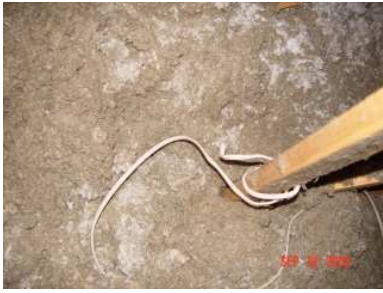
5C. Summary Page Item:

Loose wiring modifications were not completed, leaving exposed wiring and questionable practices. This is a potential for an electrical hazard and needs immediate repair. Recommend repair by professional licensed electrician.

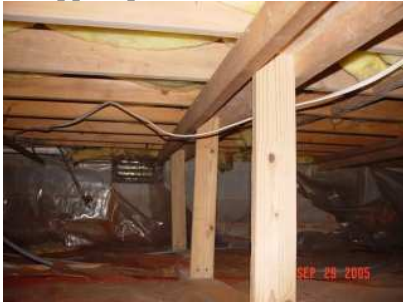
5D. Electrical wiring needs to be properly secured in the crawl space. This wire is runs between the added support posts to the left of the crawl space entrance.

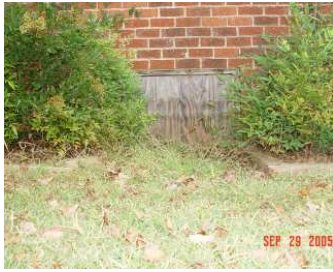
1. Summary Page Item:

Crawlspace door is below grade. This can cause water to drain into the crawlspace area. This area needs additional water blocking and landscape changes to prevent future problems.

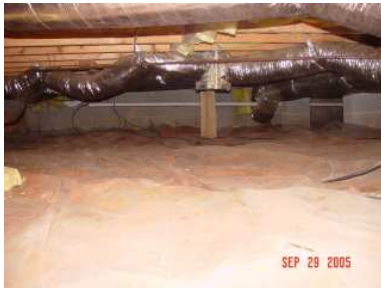
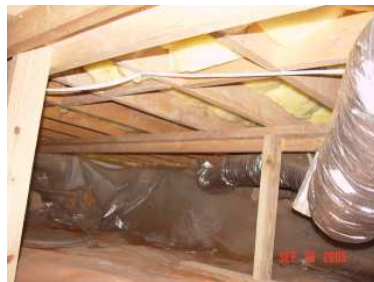
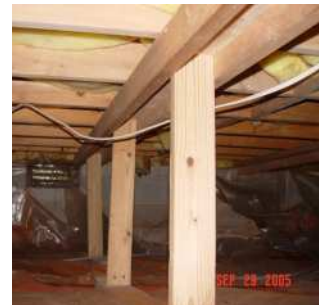
9. Additional beam supports have been added to the original construction in the area under the living room. The floor joists in the area show no signs of cracking or deterioration. The supports appear to be to remove any bounce in the living room floor. The walking area above showed no signs of problems.

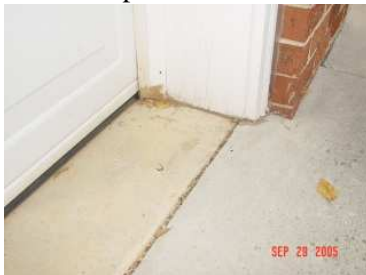
5. Summary Page Item:

Garage door trim has a few places that are starting to deteriorate. I tested the deteriorated trim with a small probe.

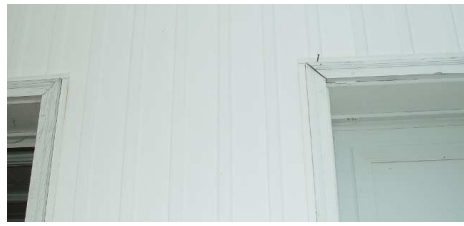
6. Paint is deteriorating and peeling above the garage door and also at the small entrance door on the south end of the home. These areas will let deterioration occur if not corrected. These areas need to be repaired by licensed general contractor or professional painter. 3 photos below

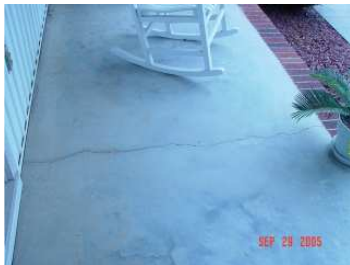
8. Crack running through front porch concrete. Photo below

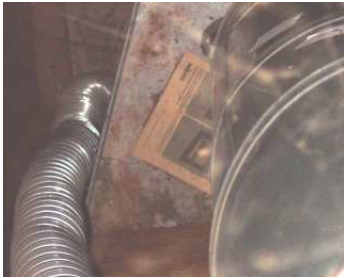
6. Summary Page Item:

The installation manual for the fireplace is lying on top of the firebox. This photo is taken from the attic from which it could not possible be reached.. This item on the firebox creates the possibility of a fire and should be corrected immediately. Have a licensed general contractor or HVAC company remove the manual and test the fireplace after the removal.

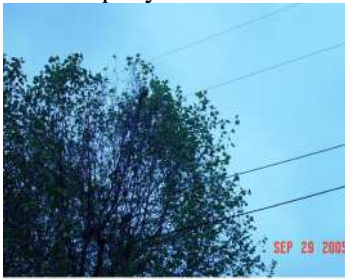
2. Summary Page Item:

Tree in front yard has power lines from the utility company running through the branches. This poses a risk of electrical hazard. Needs to be trimmed by licensed professional tree company.

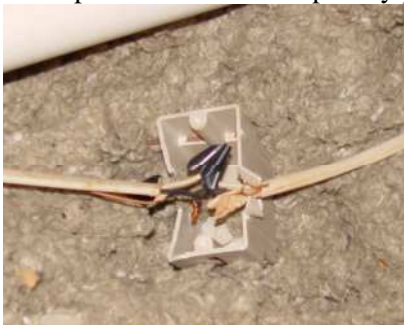
5A. Summary Page Item:

An exposed wiring in a non standard junction box without a cover was found within 4 feet over from the attic stairs. This is a potential for an electrical hazard and needs immediate repair. Recommend repair by professional licensed electrician.

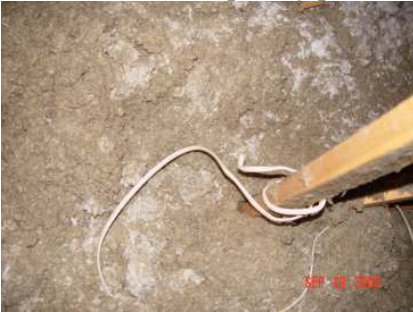
5C. Summary Page Item:

Loose wiring modifications were not completed, leaving exposed wiring and questionable practices. This is a potential for an electrical hazard and needs immediate repair. Recommend repair by professional licensed electrician.

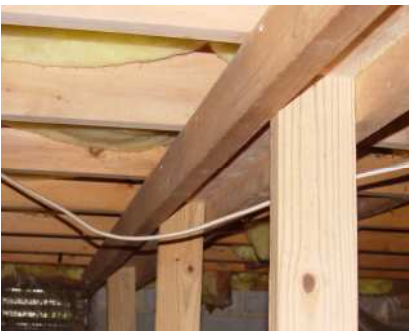
5D. Electrical wiring needs to be properly secured in the crawl space. This wire is runs between the added support posts to the left of the crawl space entrance.

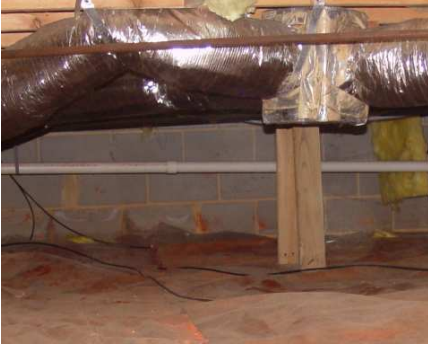
5E. Cable wiring needs to be attached to joist to avoid damage from moisture or other hazards

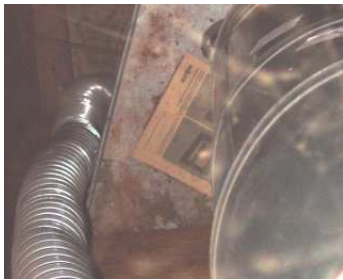
21. Summary Page Item: (Repeat from roof section)

The installation manual for the fireplace is lying on top of the firebox. This photo is taken from the attic from which it could not possible be reached.. This item on the firebox creates the possibility of a fire and should be corrected immediately. Have a licensed general contractor or HVAC company remove the manual and test the fireplace after the removal.
